Hill County Traffic Safety Improvements Study

prepared by Robert Peccia & Associates
Helena, Montana
September, 1989

Hill County, Montana

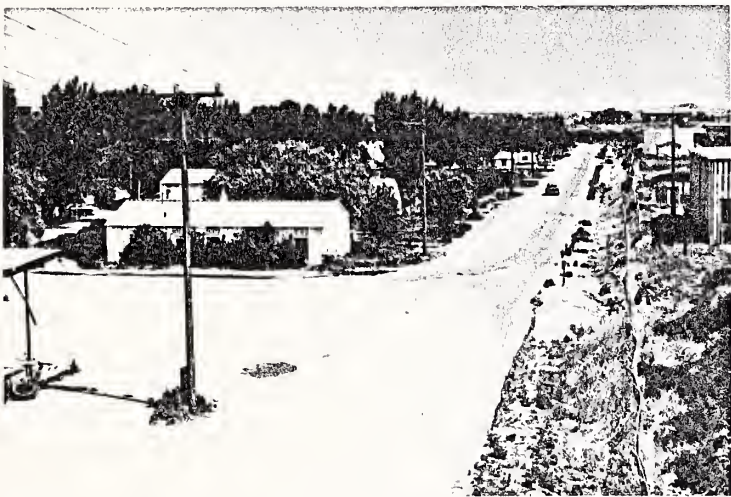
Photograph 1

Photograph 1: This view of the site from the viaduct shows the long straight approach to the intersection on First Street North. The white building on the corner limits the sight distance at the intersection.

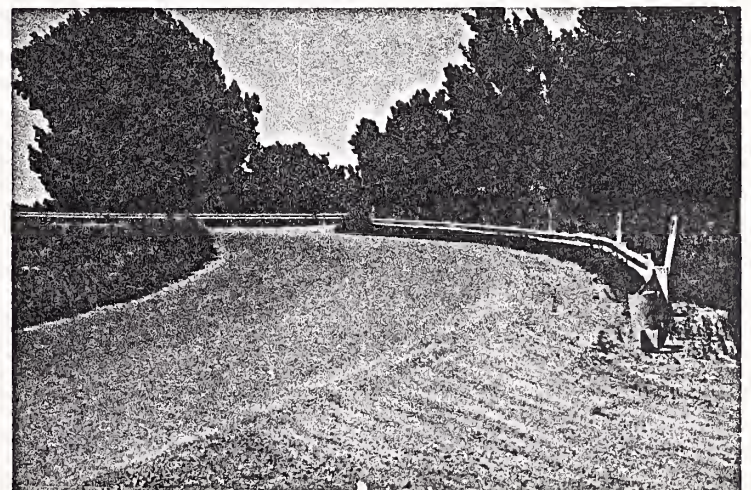
Photograph 4

Photograph 4: A series of amber reflectors have been installed behind the guardrail on Eighth Avenue North. Amber reflectors are normally used to delineate the left side of a one-way road. White reflectors should be used at this location.

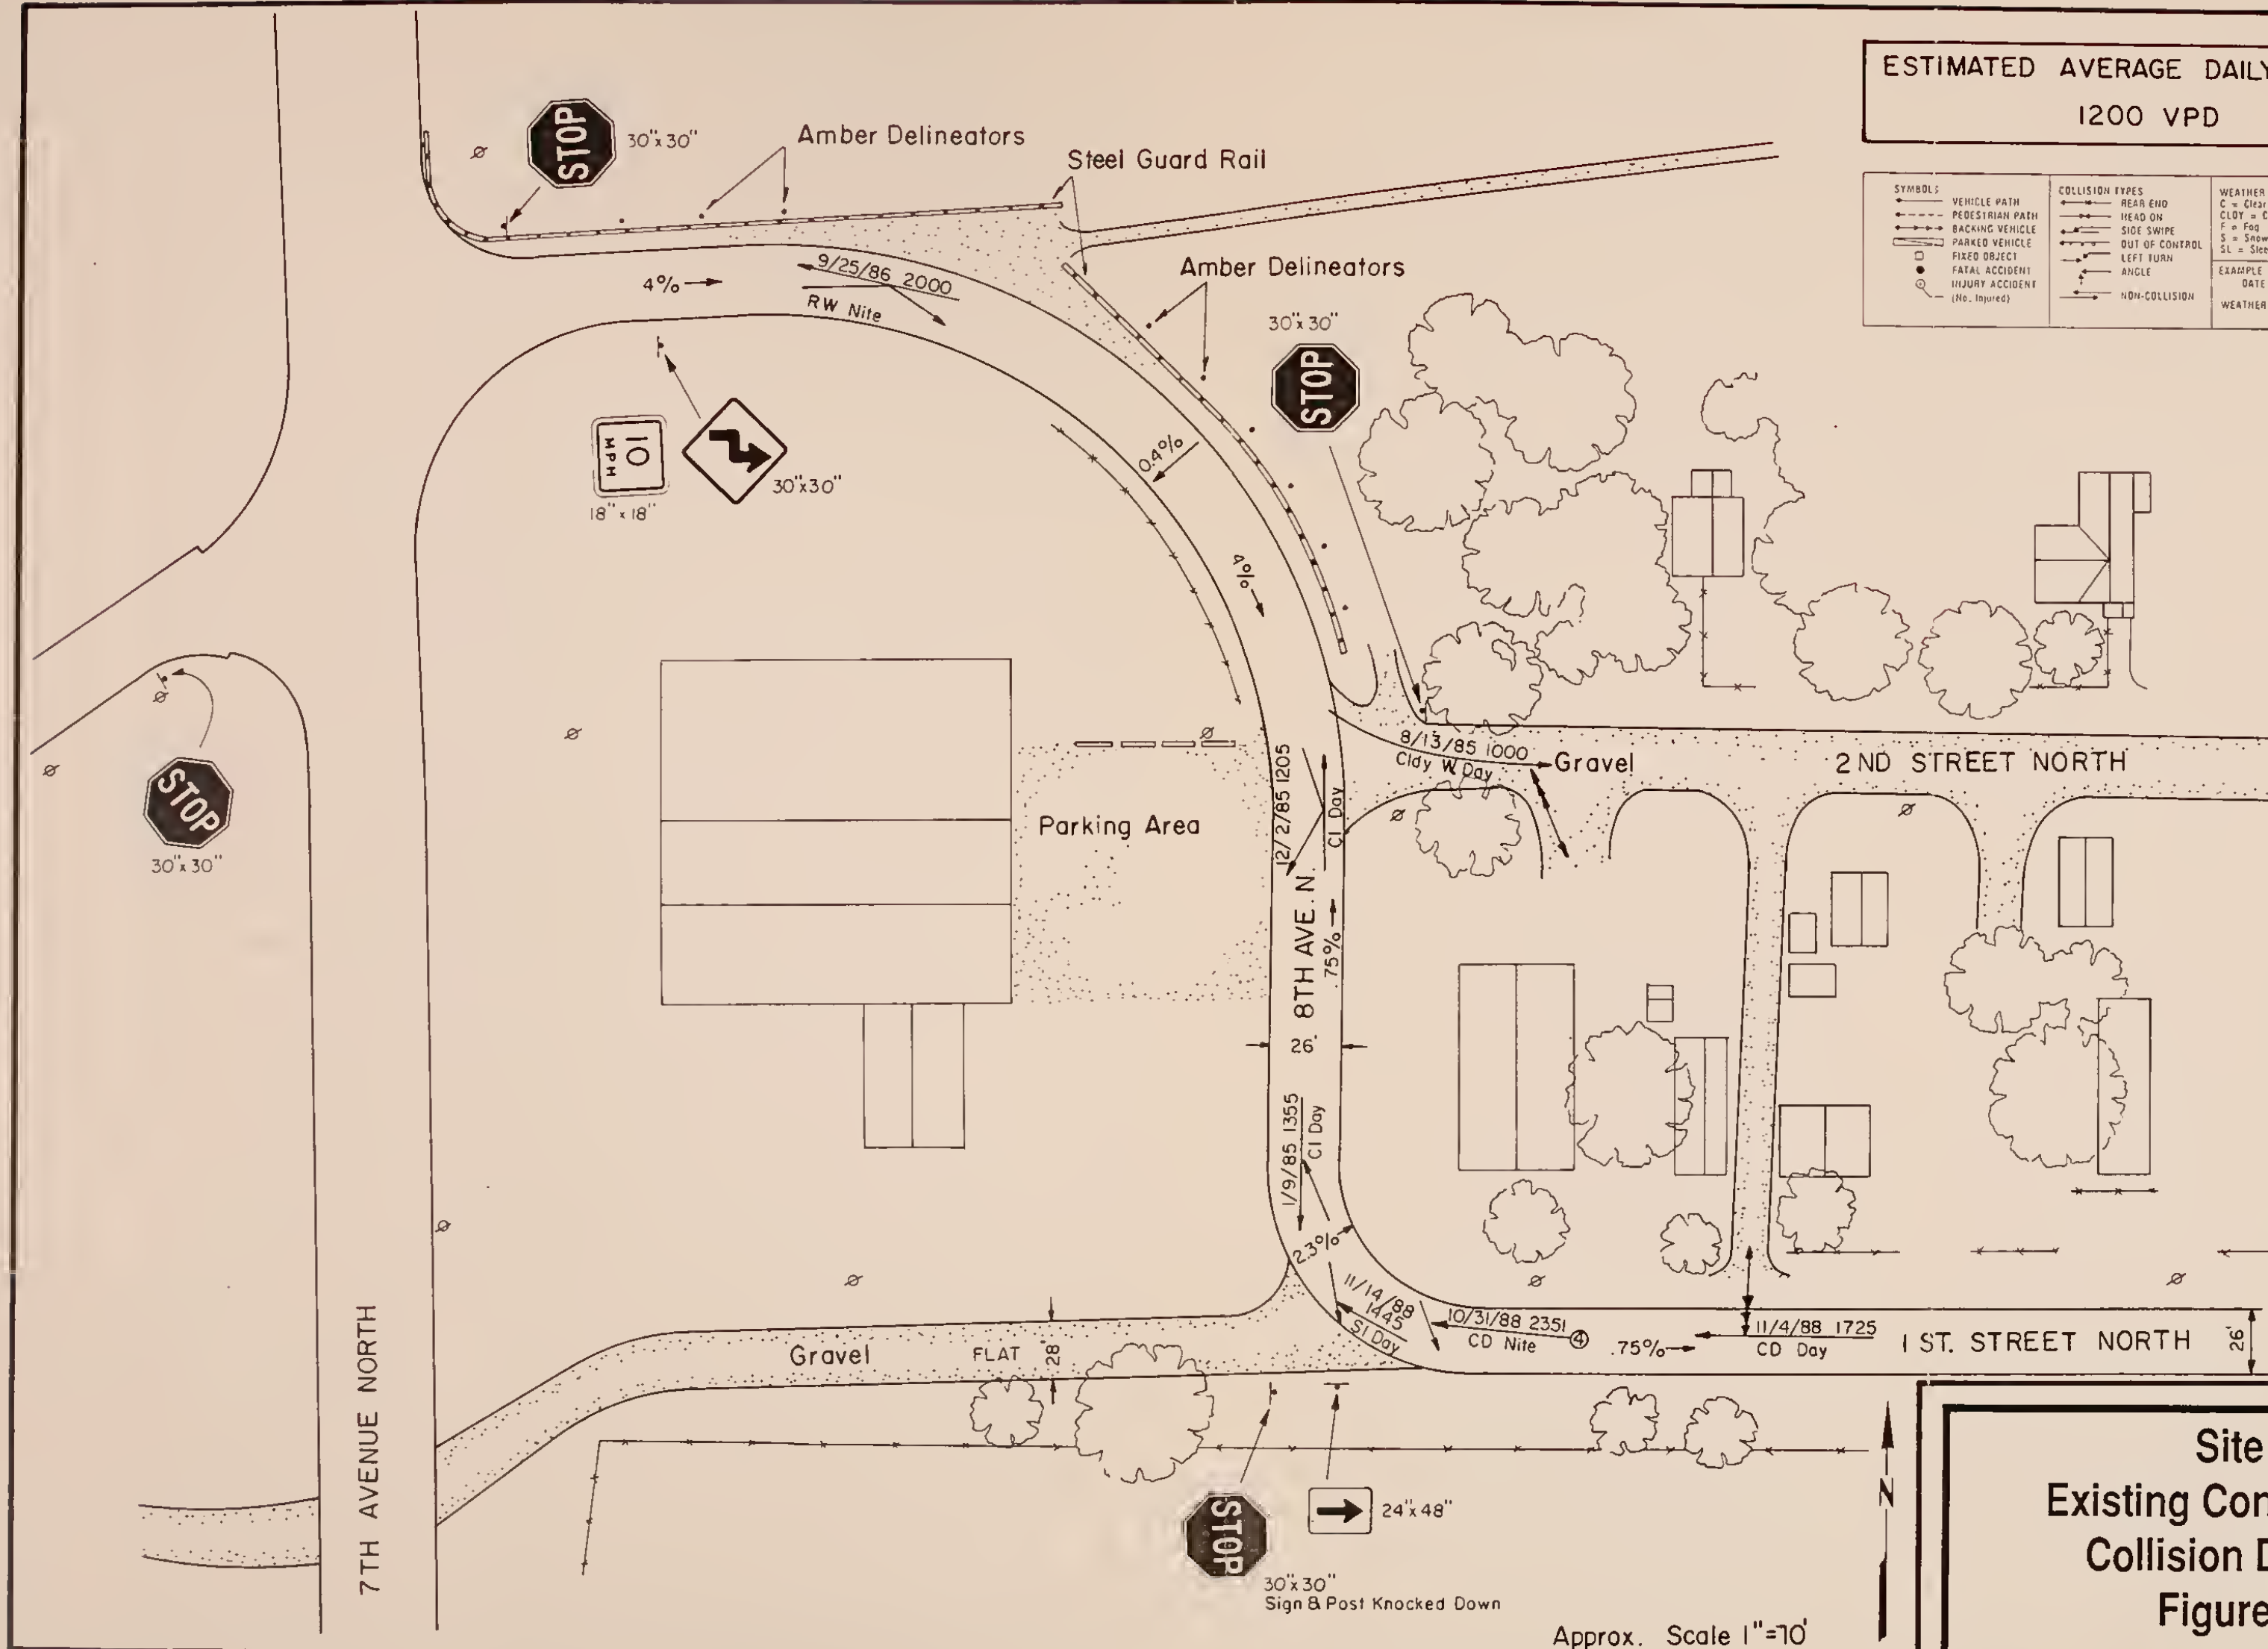
Site 1
Existing Conditions &
Collision Diagram
Figure 1A

Seven multi-vehicle accidents occurred at this site during the four-year study period. There were three angle collisions, two sideswipes, and two cases where a vehicle backed out of a driveway and struck a passing car. The collision diagram in Figure 1A shows the location of each accident at this site. The three-angle accidents occurred at the intersection of First Street and Eighth Avenue. One of these collisions resulted in injuries to four people. Excessive speed was the cause of two of these angle accidents. Alcohol was involved in two of the seven accidents. The data below shows additional facts relating to the four-year accident history at this location.

The major problem at this site is a combination of limited sight distance and excessive vehicle speeds. Unfortunately, the sight-distance problem is caused by a building located on the northeast corner of the intersection of Eighth Avenue and First Street, which cannot be easily removed. A ball bank indicator was used to determine that 10 mph is the maximum safe speed for this site. Motorists require additional information and warning of the conditions at this location.

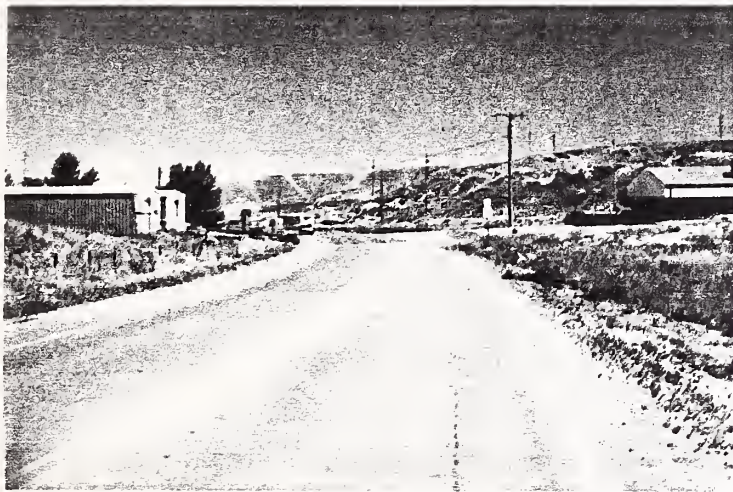
Photograph 1

Photograph 1: The speed limit changes from 45 to 35 mph as you approach the site from the west. Second Street slopes toward the east at a rate of approximately 3%.

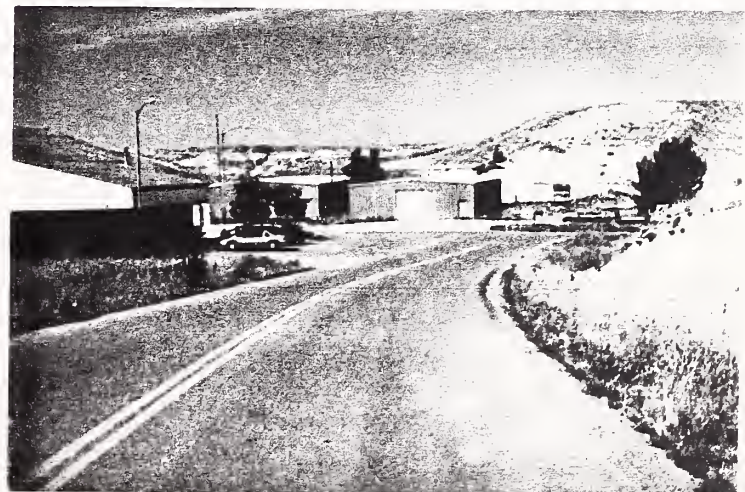
Photograph 4

Photograph 4: The Athletic Club, shown on the left in this picture of the intersection, blocks the driver's view of traffic approaching the intersection from the west.

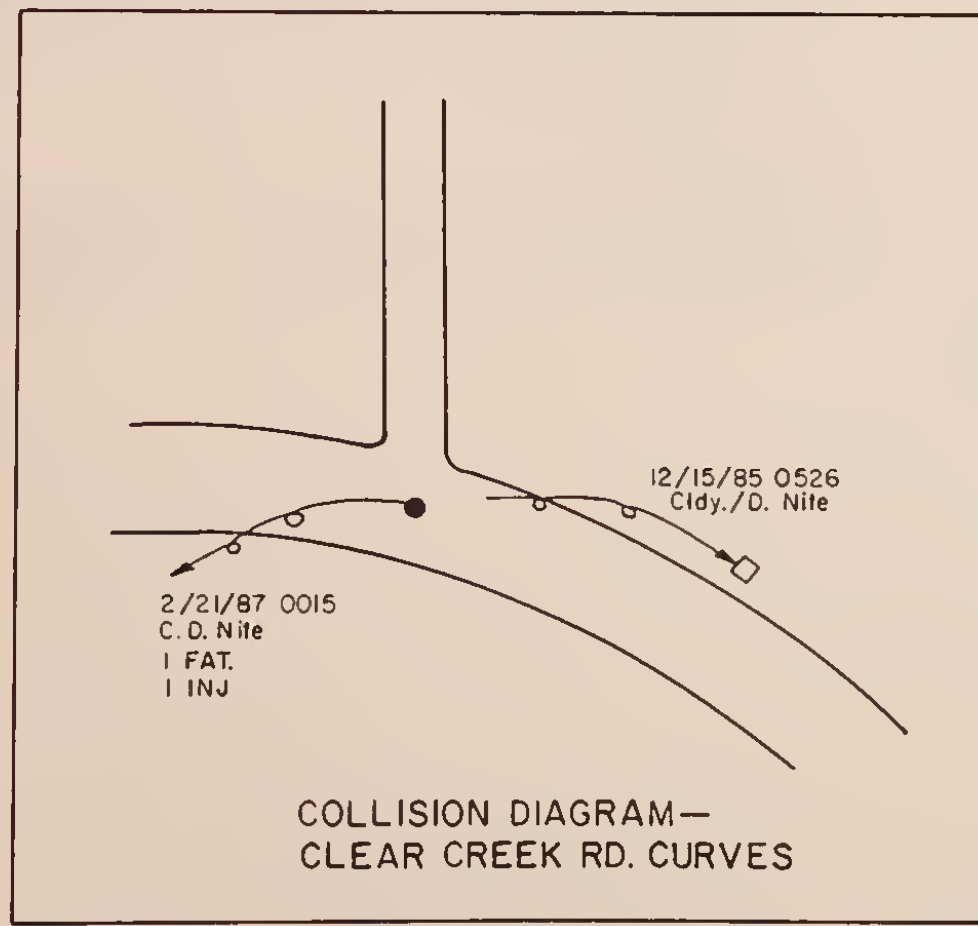
Site 7
Existing Conditions &
Collision Diagram
Figure 7A

The curve in the Clear Creek Road is the result of a 30° change in roadway alignment and has a superelevation of 6.5%. The overall grade slopes toward the west at approximately 2%. The geometric layout of the site is shown in Figure 7A. Traffic counts taken by the Department of Highways in 1988 indicate this portion of Clear Creek Road has an average daily traffic volume of 490 vehicles.

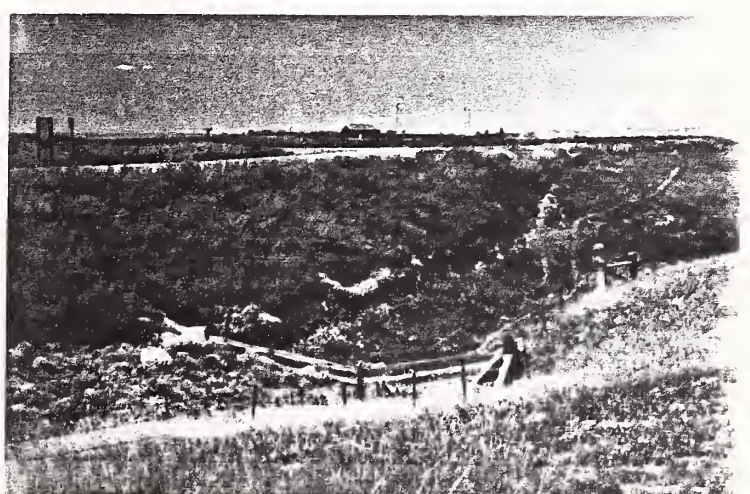
Photograph 4

Photograph 4: This picture was taken from the field north of the intersection. It shows the large coulee that is immediately north of this site.

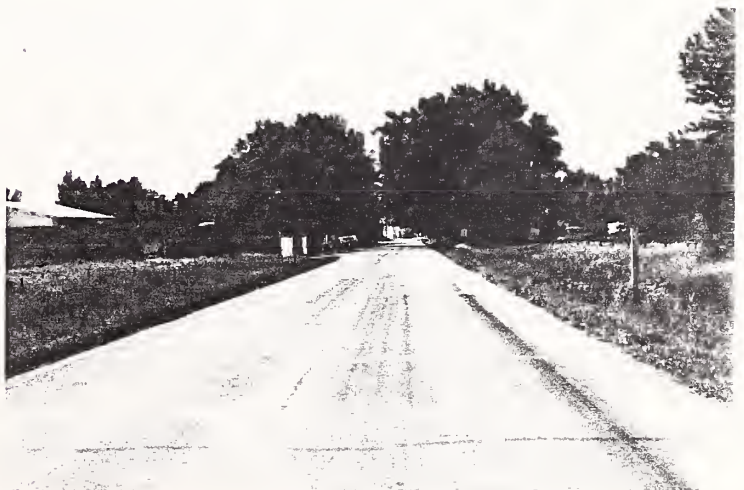
Photograph 4

Photograph 4: This view of Main Street, looking west, shows the Box Elder School on the left. A speed limit sign indicating 15 mph is located across from the school.
